# Debris/Ice/TPS Assessment And Photographic Analysis For Shuttle Mission STS-42

March 1992

National Aeronautics and  
Space Administration

**Gregory N. Katnik**  
**NASA/Kennedy Space Center**

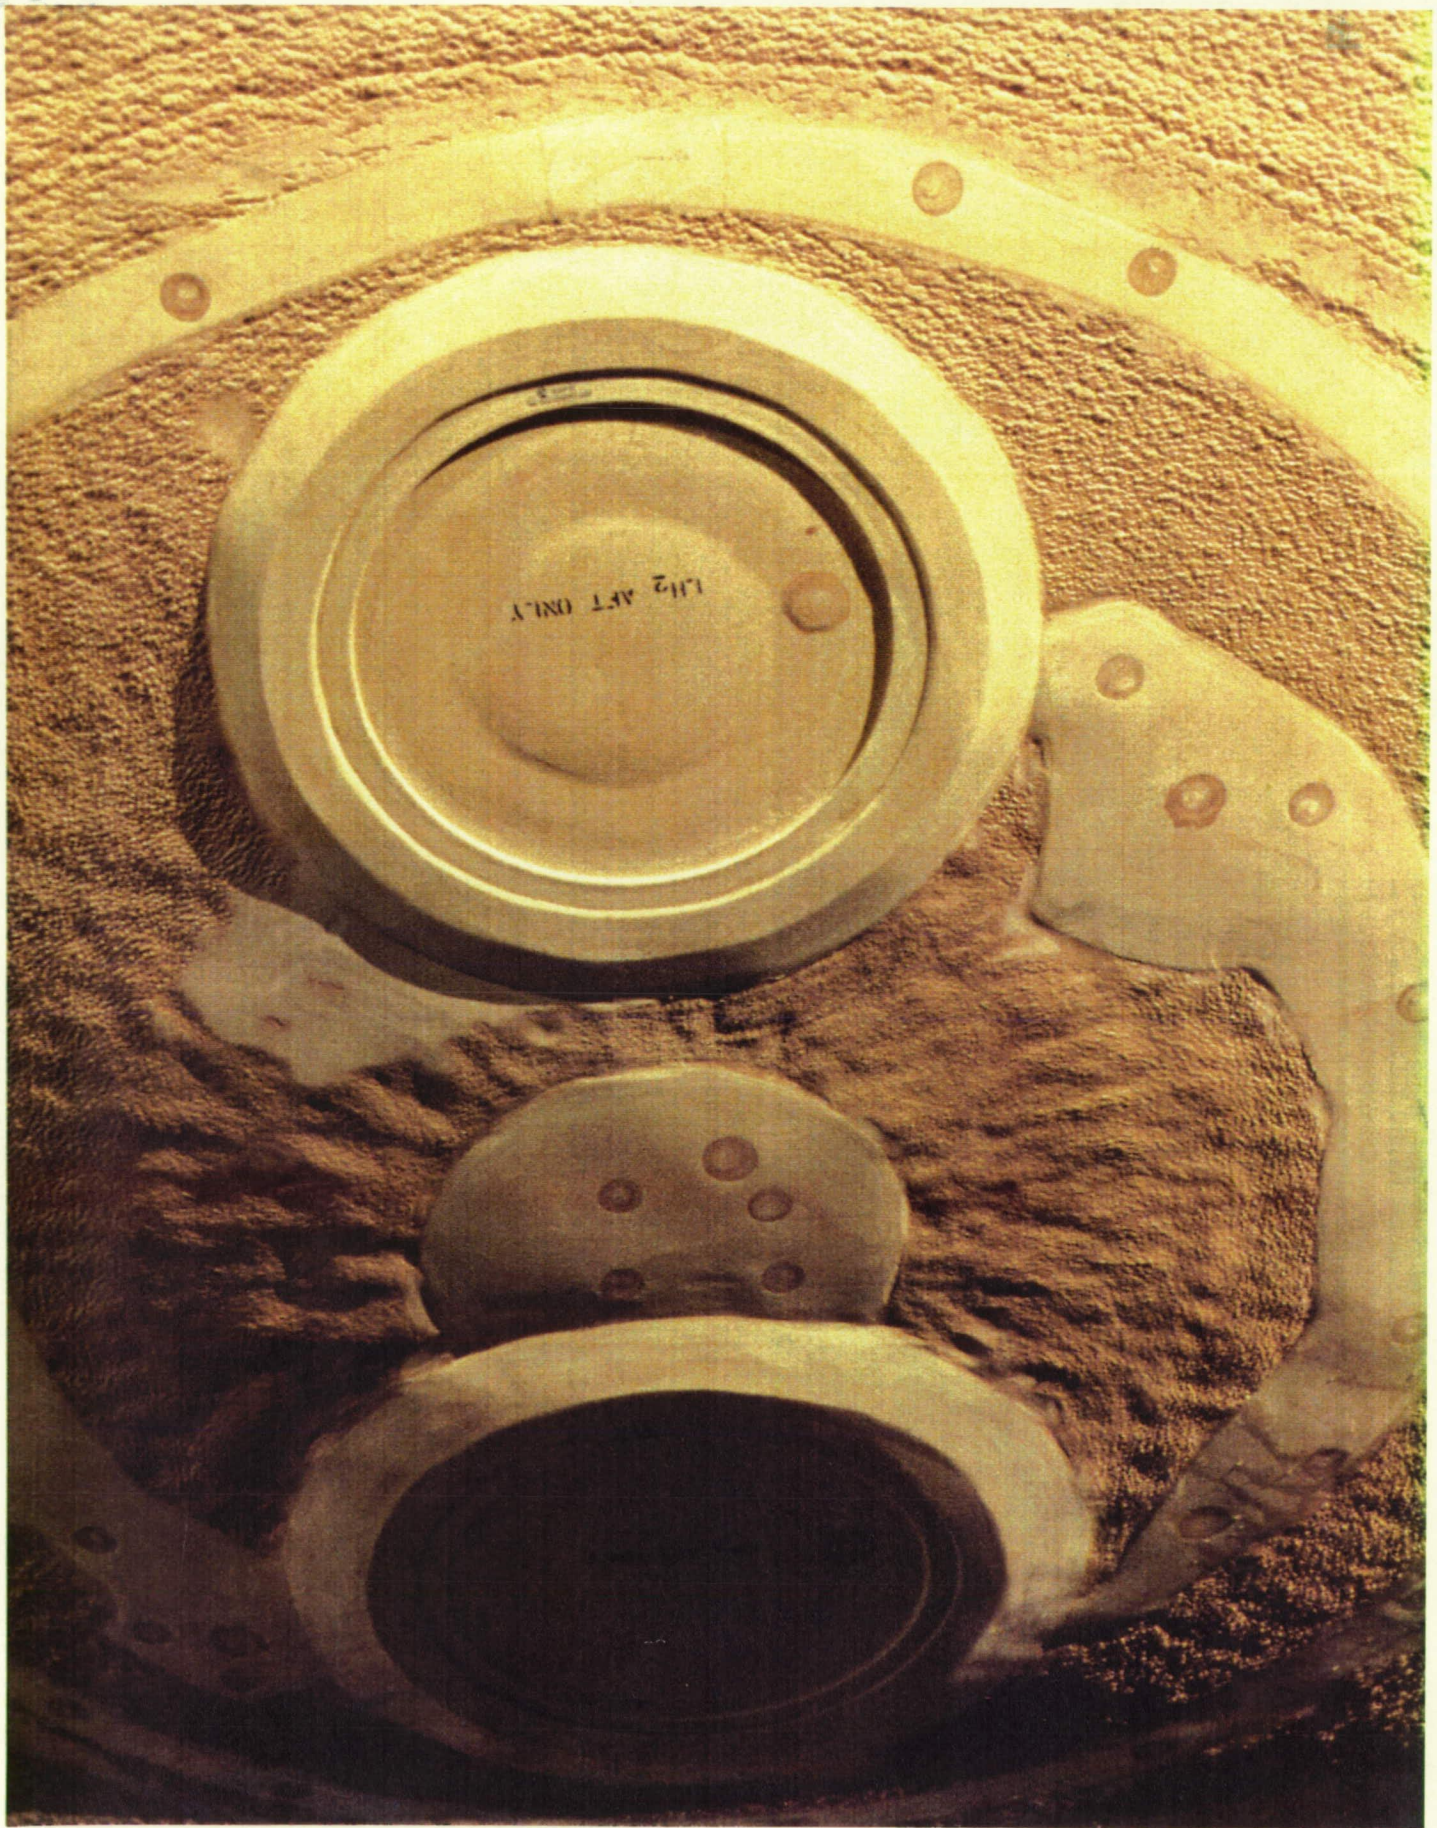
Ice/frost formations on the lower plate gap purge vent, the aft pyro canister purge vent, and in the LH2 recirculation line bellows were typical. The cable tray vent hole and 17-inch flapper valve actuator tool access port closeout exhibited no ice or frost accumulations.

Overall view of ET aft dome apex and manhole covers

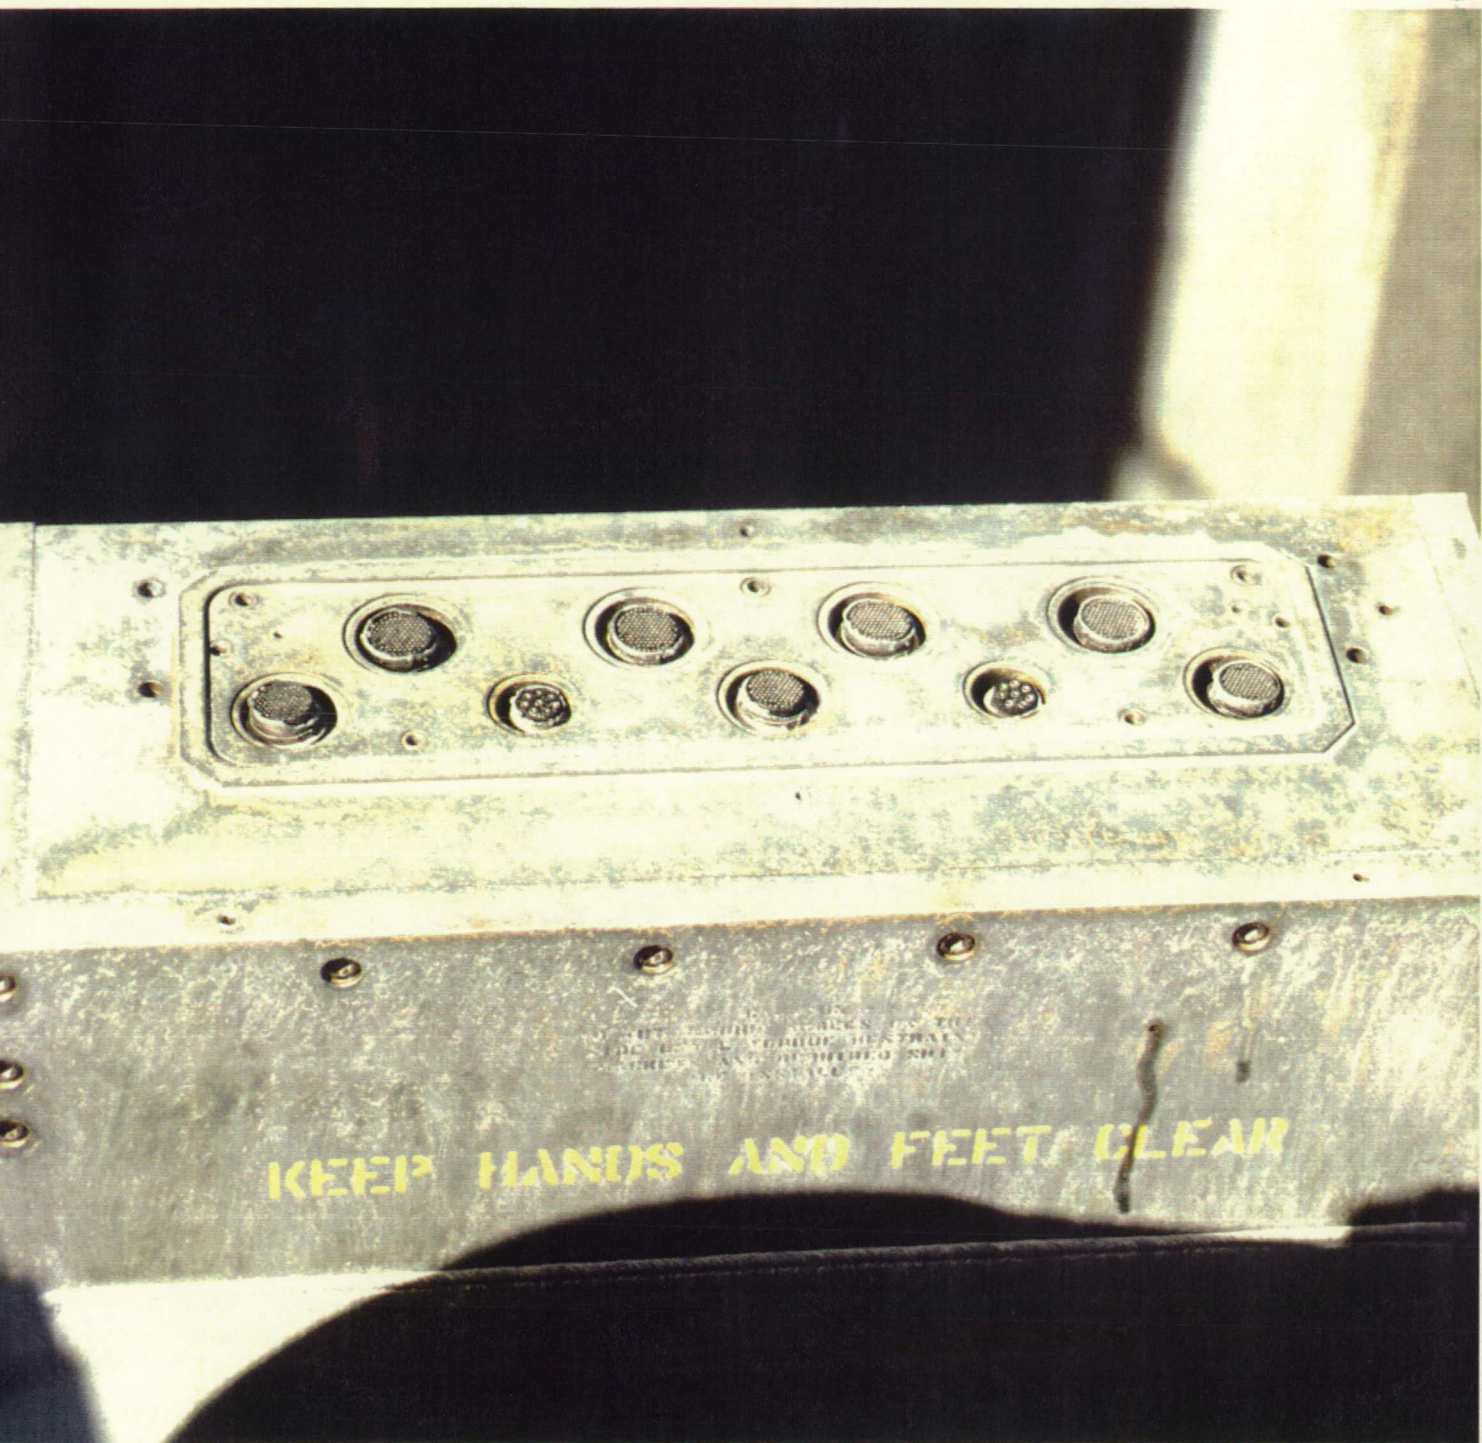
Post launch condition of the SRB T-0 umbilical carrier plate  
and electrical connector sacrificial pieces

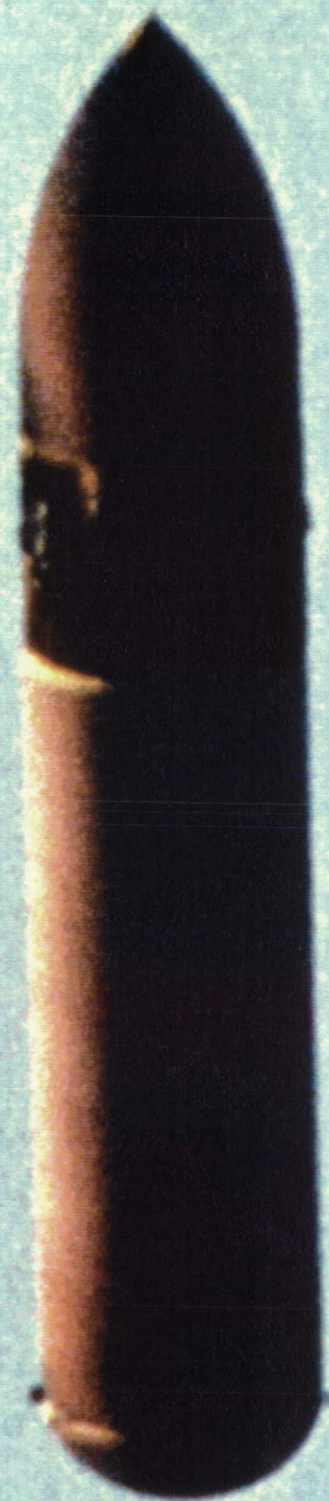
On-orbit view of the External Tank shortly after separation from the Orbiter. No major damage or lost flight hardware was observed that would have been a safety-of-flight concern.

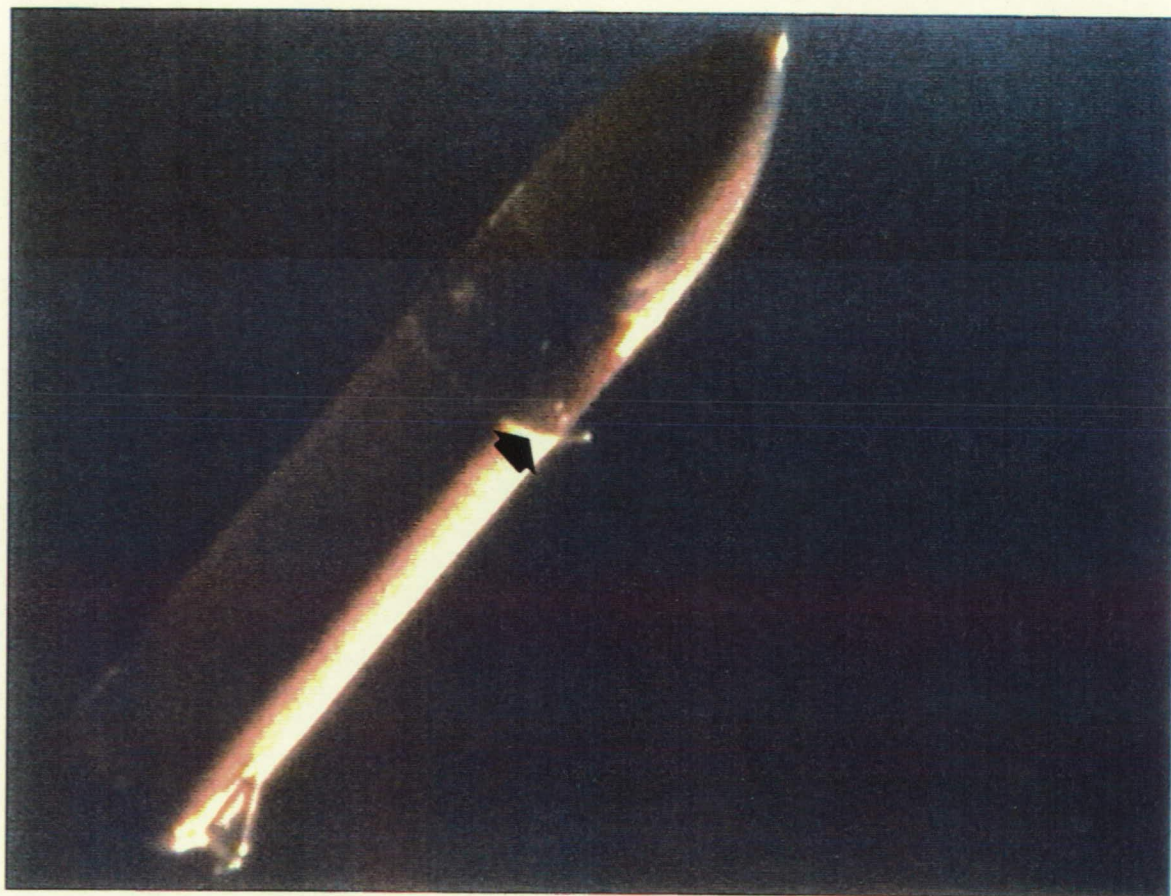
Two light spots in the intertank -Y+Z quadrant acreage outboard of the -Y bipod ramp and forward of the intertank-to-LH2 tank flange closeout appeared to be possible divots 8-12 inches in diameter. No anomalies were visible on the nosecone or L02/LH2 tank acreage areas.

View of External Tank -Y side showed the two divots in the intertank acreage near the bipods. Other bright features in the intertank area are the RSS antenna panel, -Y ET/SRB attach fitting, flight door, and aero vent panel.

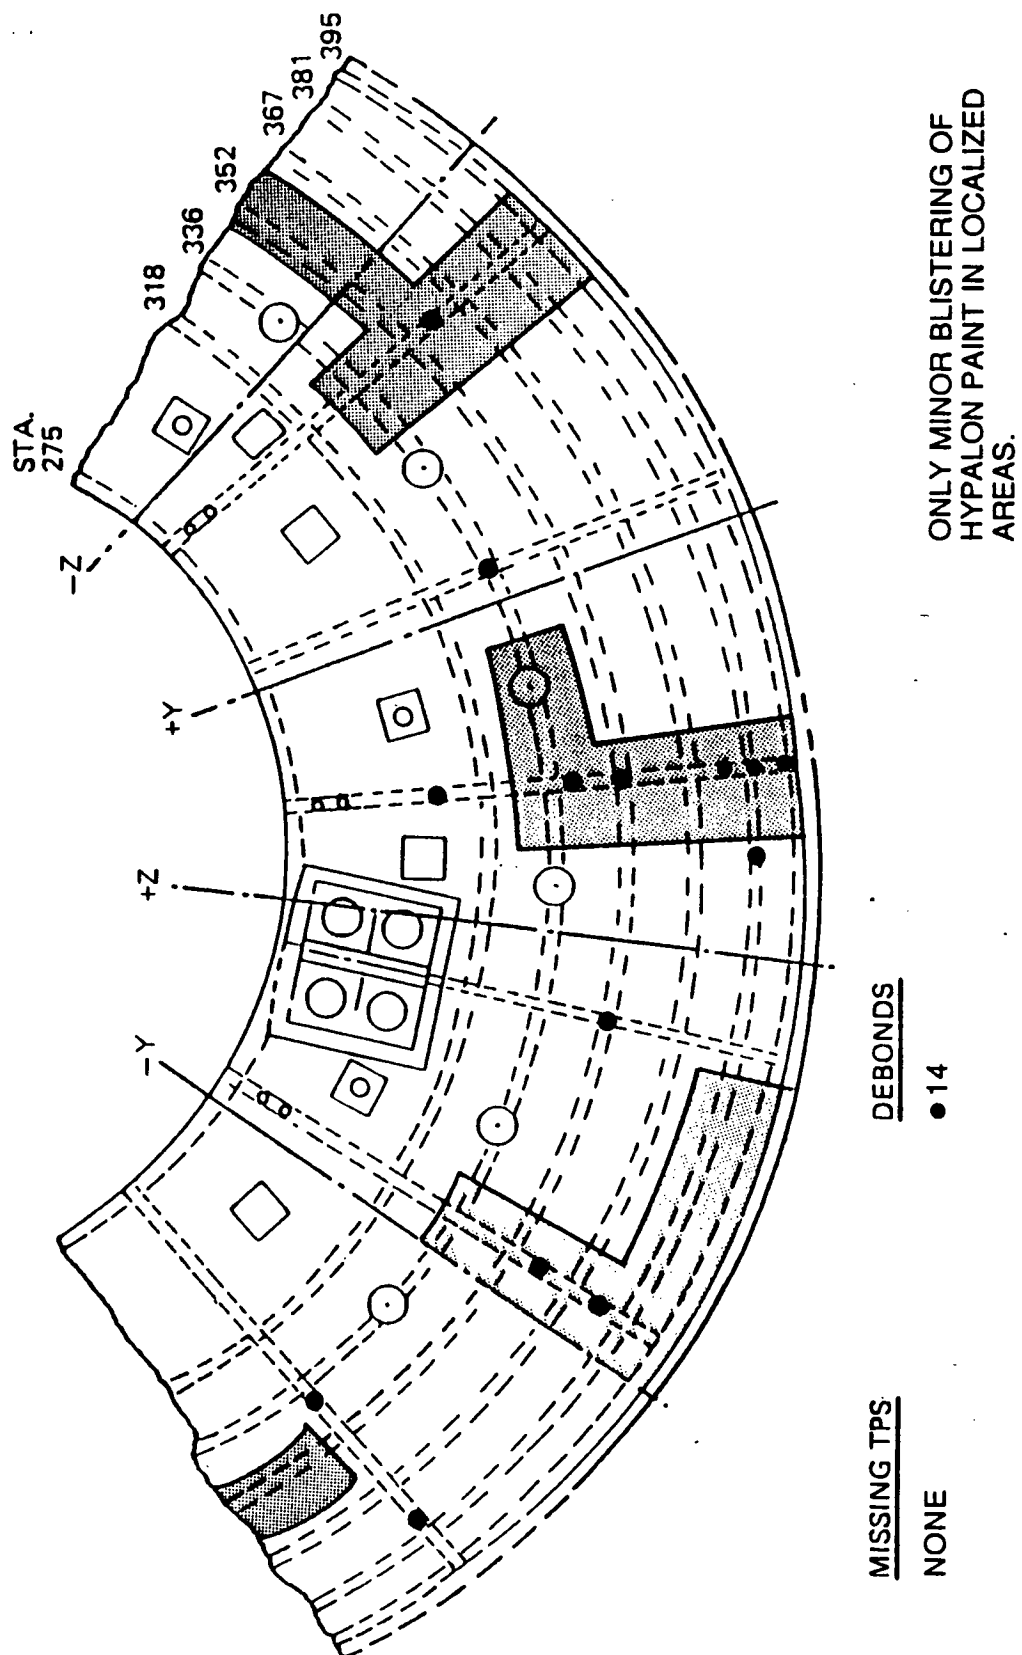
Figure 4. RIGHT SRB FRUSTUM

The RH frustum was missing no TPS but had 14 MSA-2 debonds over fasteners. There was minor localized blistering of the Hypalon paint (Figure 4). All BSM covers were locked in the fully opened position.

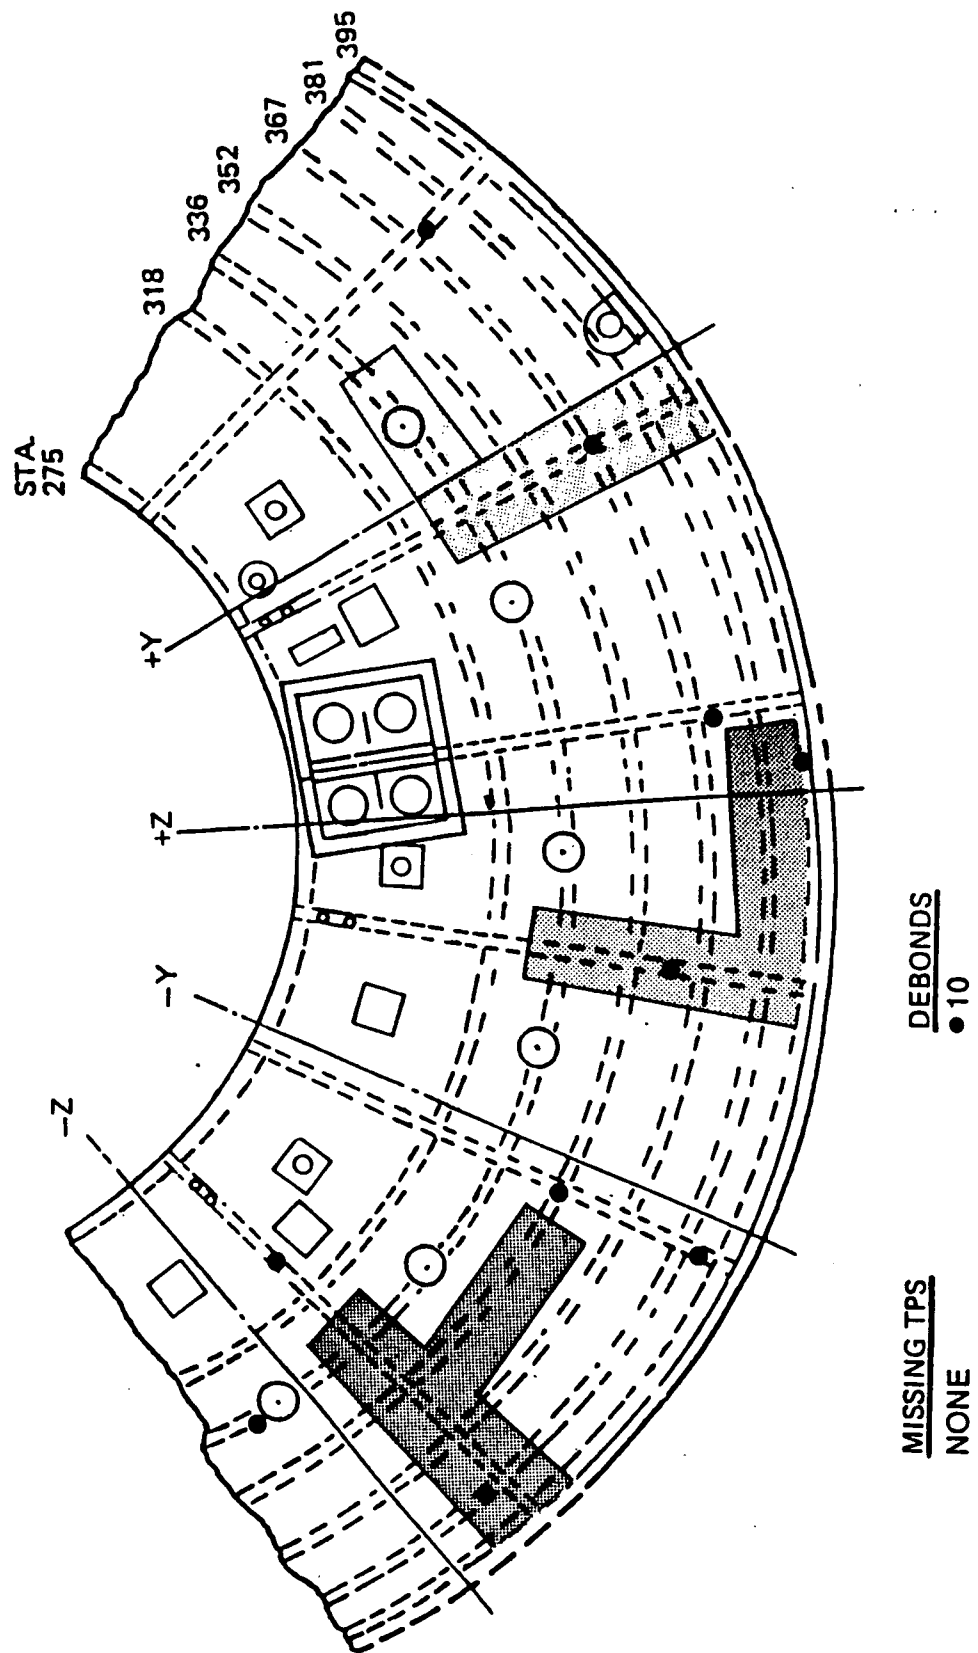
Figure 7. LEFT SRB FRUSTUM

The LH frustum was missing no TPS but had 10 MSA-2 debonds over fasteners. There was minor localized blistering of the Hypalon paint (Figure 7). The BSM covers were locked in the fully opened position though the lower left cover attach ring was deformed and the cover bent back to the 150 degree position.

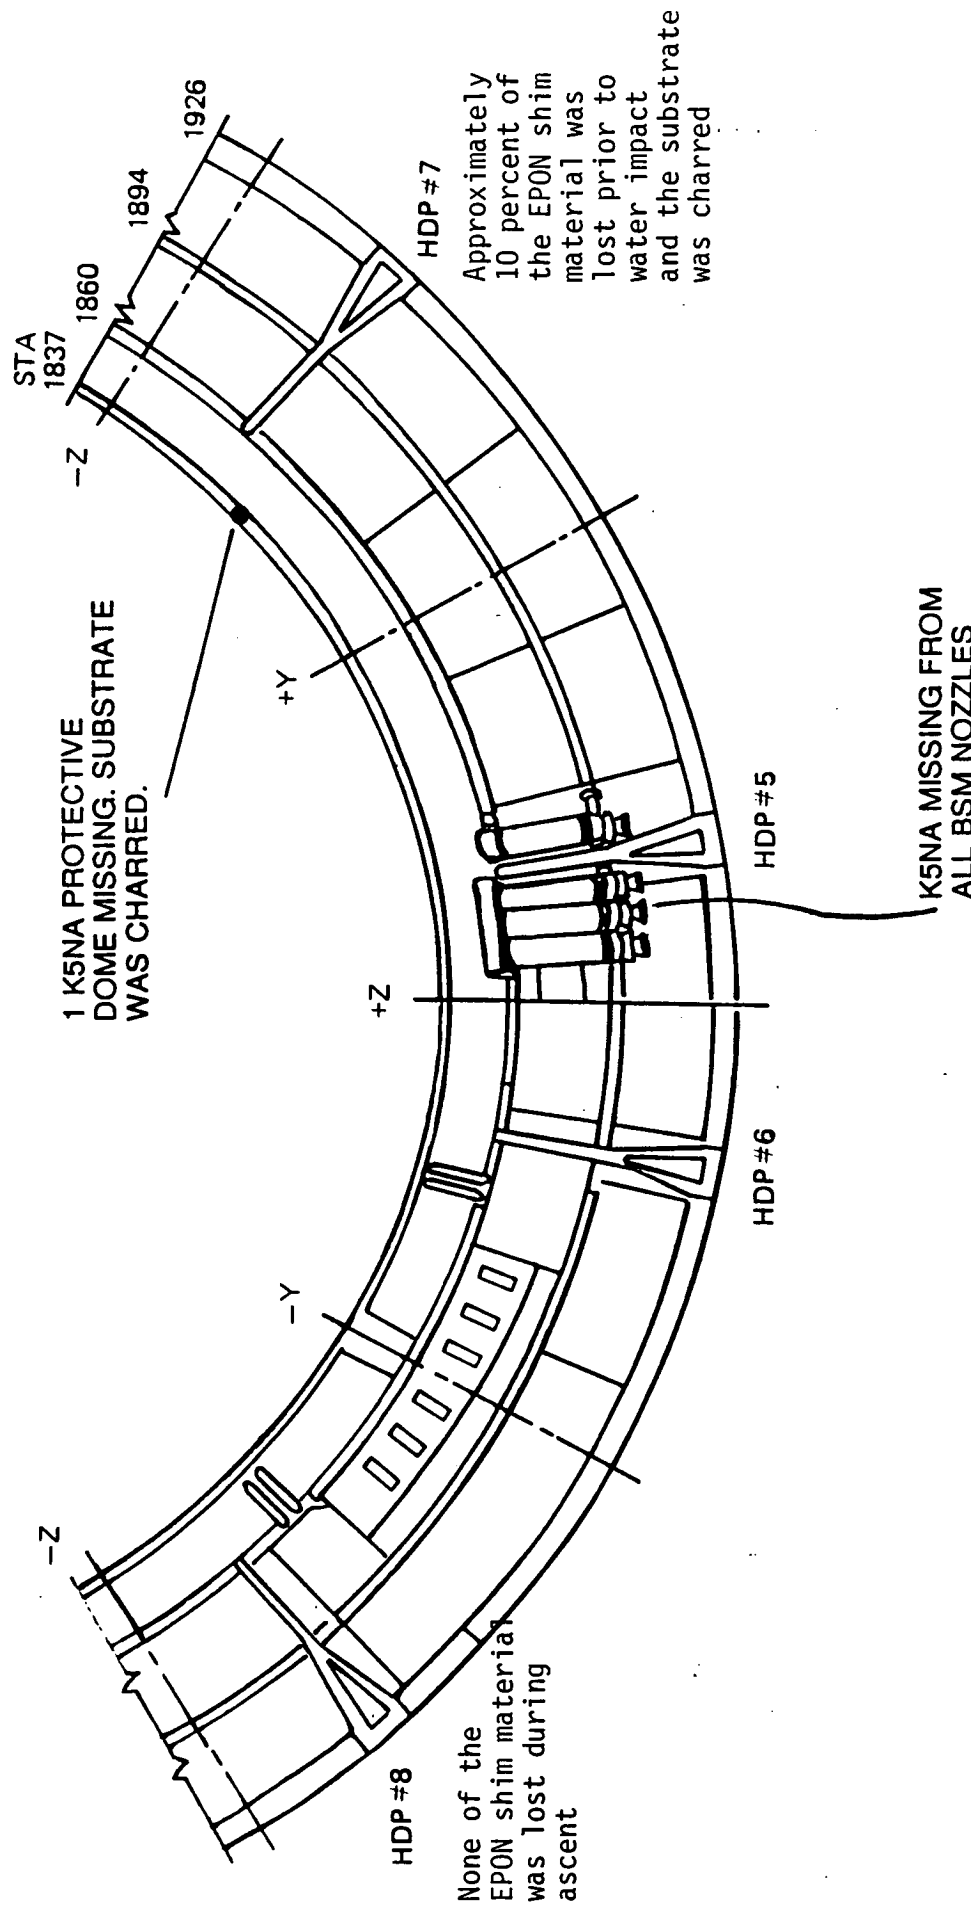
Figure 9: LEFT SRB AFT SKIRT EXTERIOR TPS

One K5NA protective dome was missing from a bolt head on the aft side of the phenolic kick ring prior to water impact (charred substrate). The aft skirt acreage TPS was generally in good condition (Figure 9). K5NA was missing from all aft BSM nozzles.

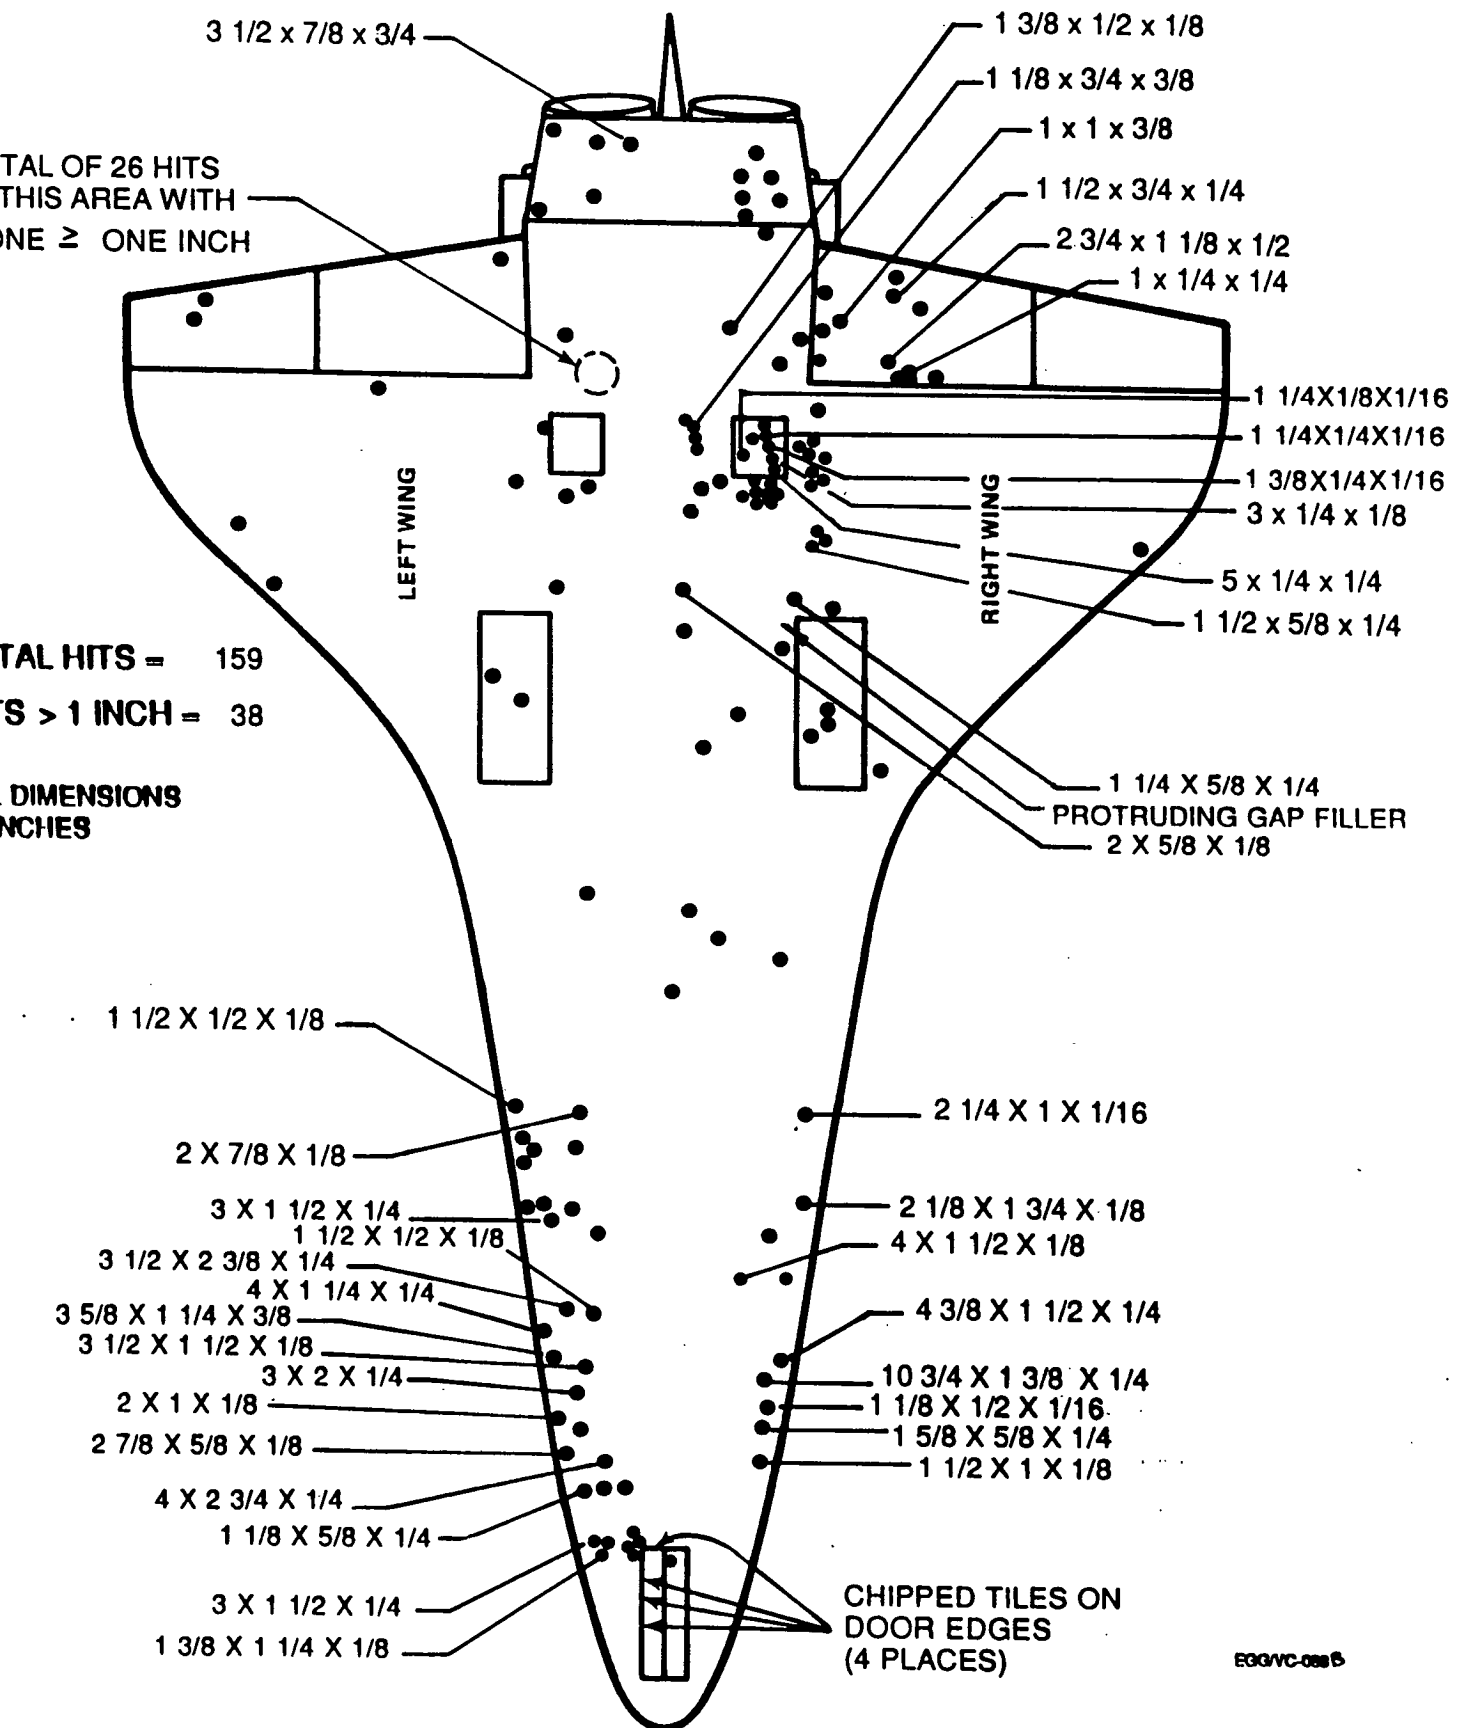
Figure 10. **STS-42**  
**DEBRIS DAMAGE LOCATIONS**

The Orbiter lower surface sustained a total of 159 hits, of which 38 had a major dimension of one inch or greater. Fourteen of these hits had a major dimension of three inches or greater with 11 of these located along the forward one-third of the vehicle (Figure 10). All of these hits were shallow (3/8 inch or less) relative to the surface area. This type of tile damage is indicative of impact by a low density material. No residual debris material was observed in any of these damage sites. However, laboratory analysis was performed on selected tiles removed (intact) at KSC for replacement.

The tile damage sites were large in surface area but shallow in depth, which is characteristic of low density impacts. The TPS on the SRB's is more dense and results in deeper penetration. A mechanism to transport ET intertank foam to the Orbiter forward lower surface area had been previously demonstrated. ET-52 was the second tank flown with the new two-gun spray process on the intertank. IFA STS-42-T-001 was taken against the loss of ET intertank foam as the probably source for the debris damage to Orbiter tiles on STS-42.

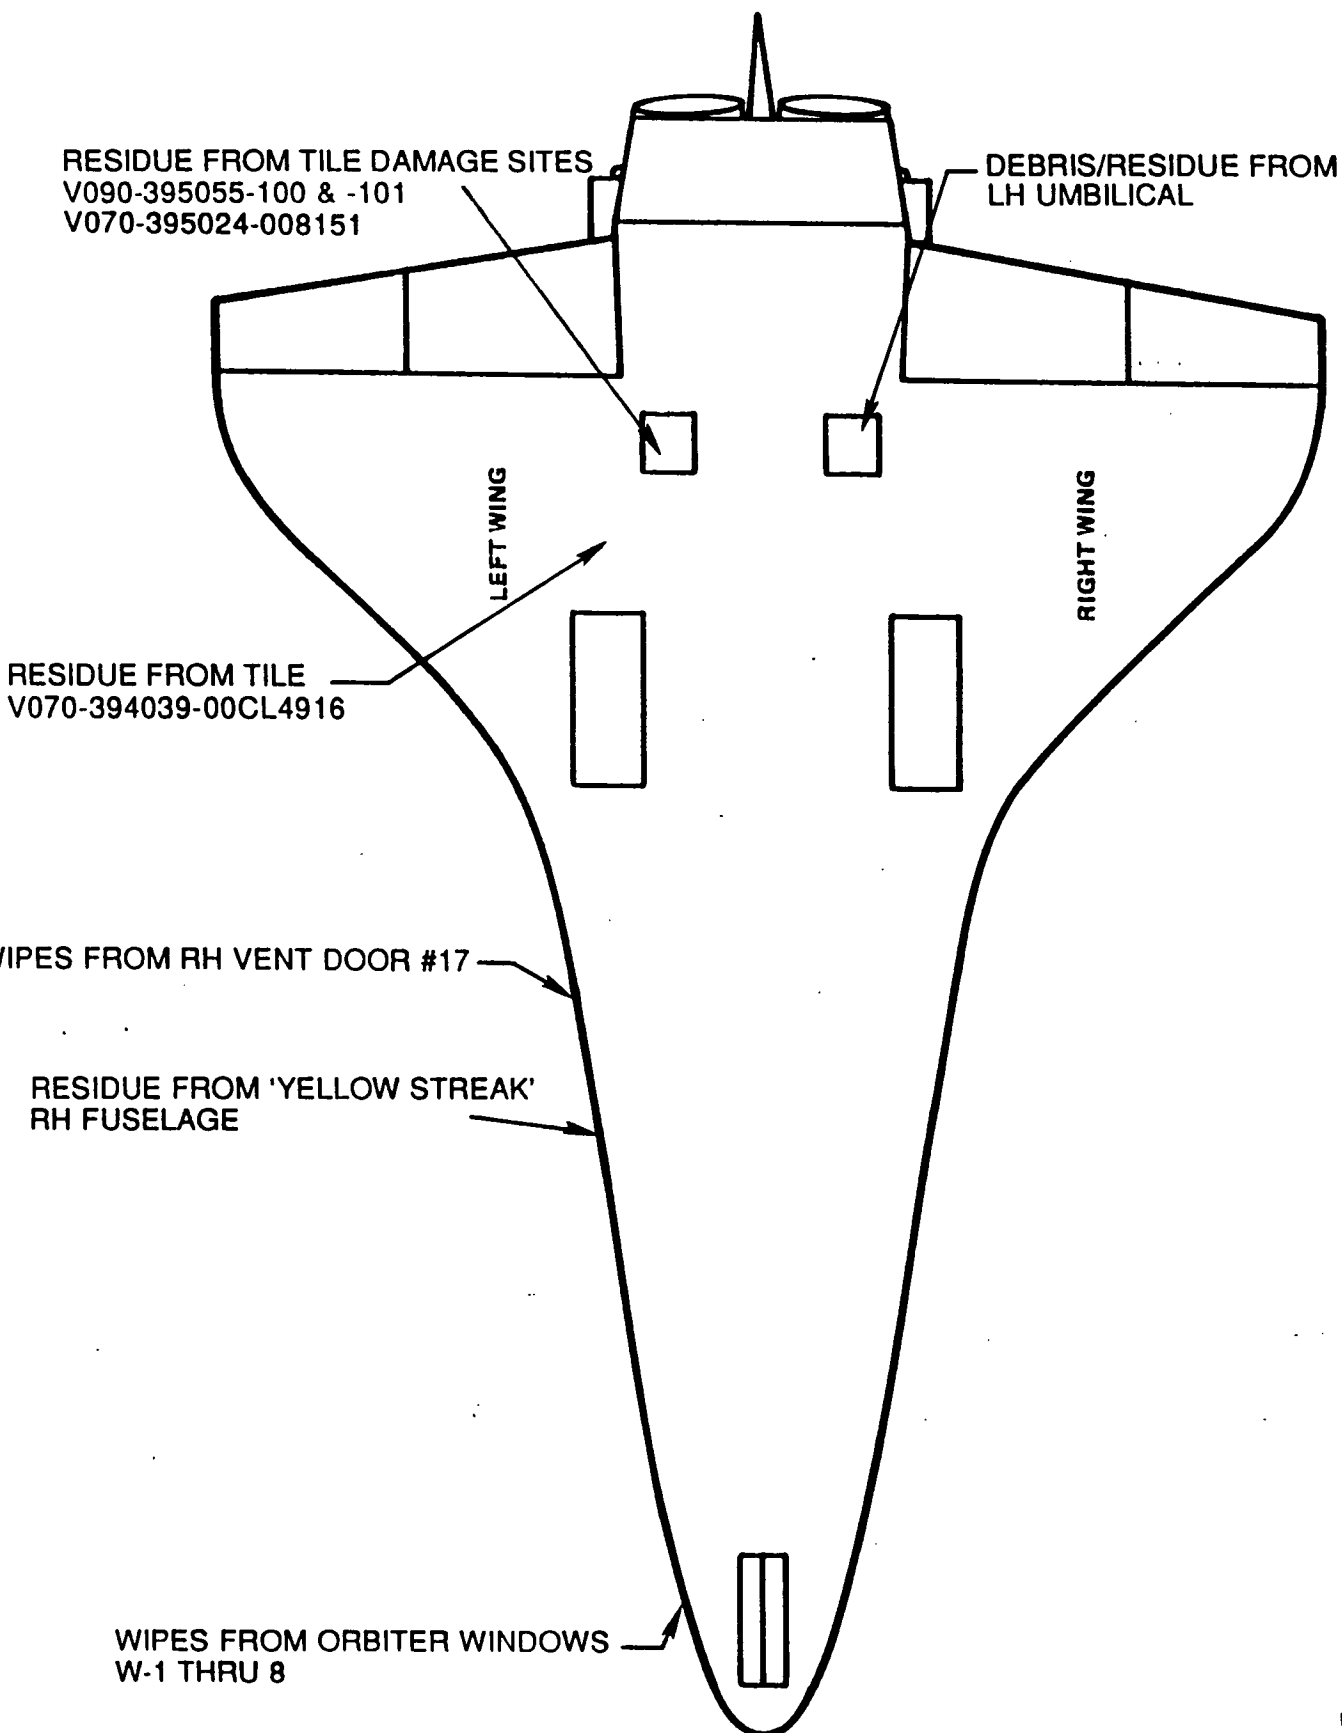
Figure 14. **STS-42**  
**CHEMICAL SAMPLE LOCATIONS**

Samples were taken from other selected sites for laboratory analysis (Figure 14). The results of all laboratory chemical analyses are presented in section 9.0.

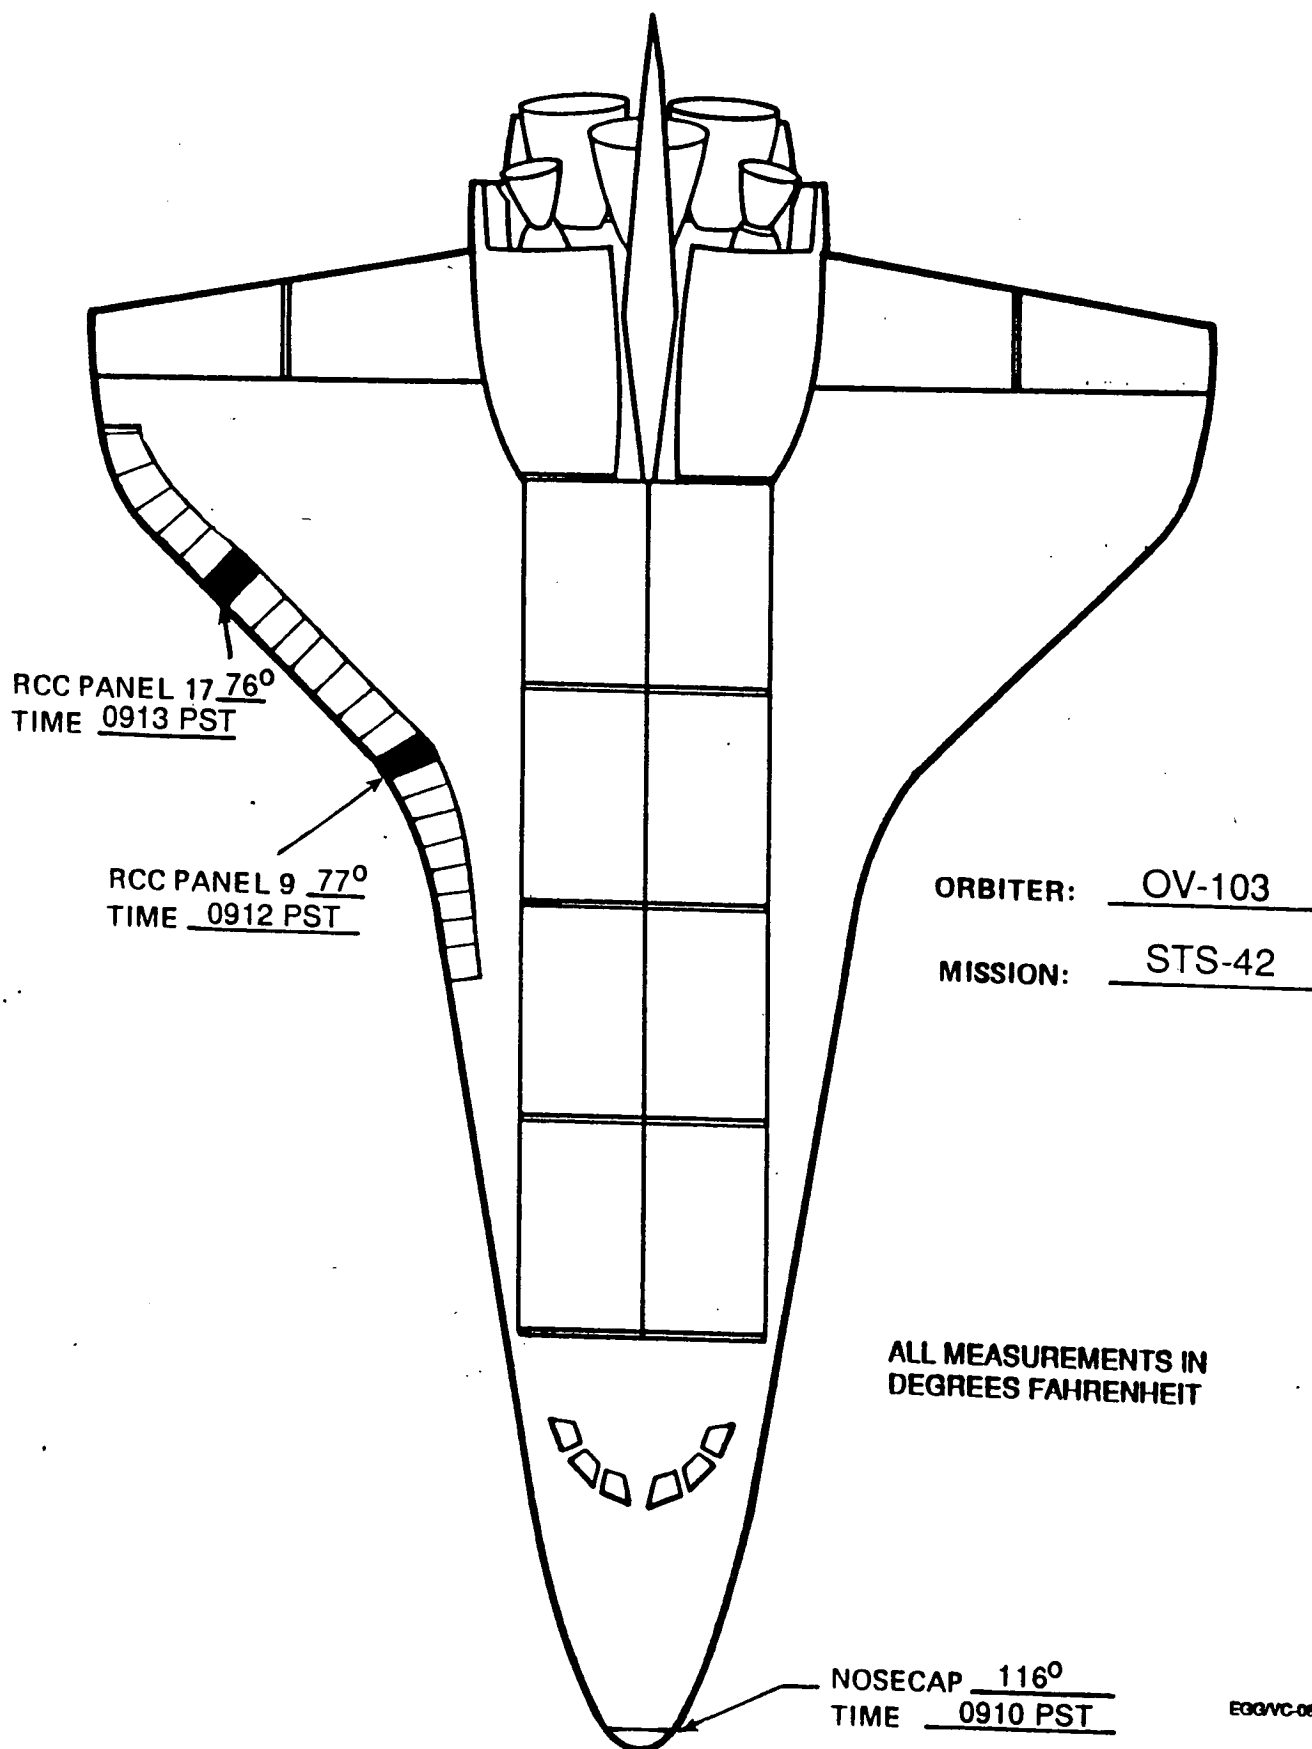
Figure 15. **STS-42 RCC TEMPERATURE MEASUREMENTS**

A portable infrared radiometer was used to measure the surface temperatures of three areas on the Orbiter TPS after landing (OMRSD V09AJ0.095). Approximately one hour after wheel stop the Orbiter nosecone RCC was 116 degrees F, the RH wing leading edge RCC panel #9 was 77 degrees F, and the RH wing leading edge RCC panel #17 was 76 degrees F (Figure 15).

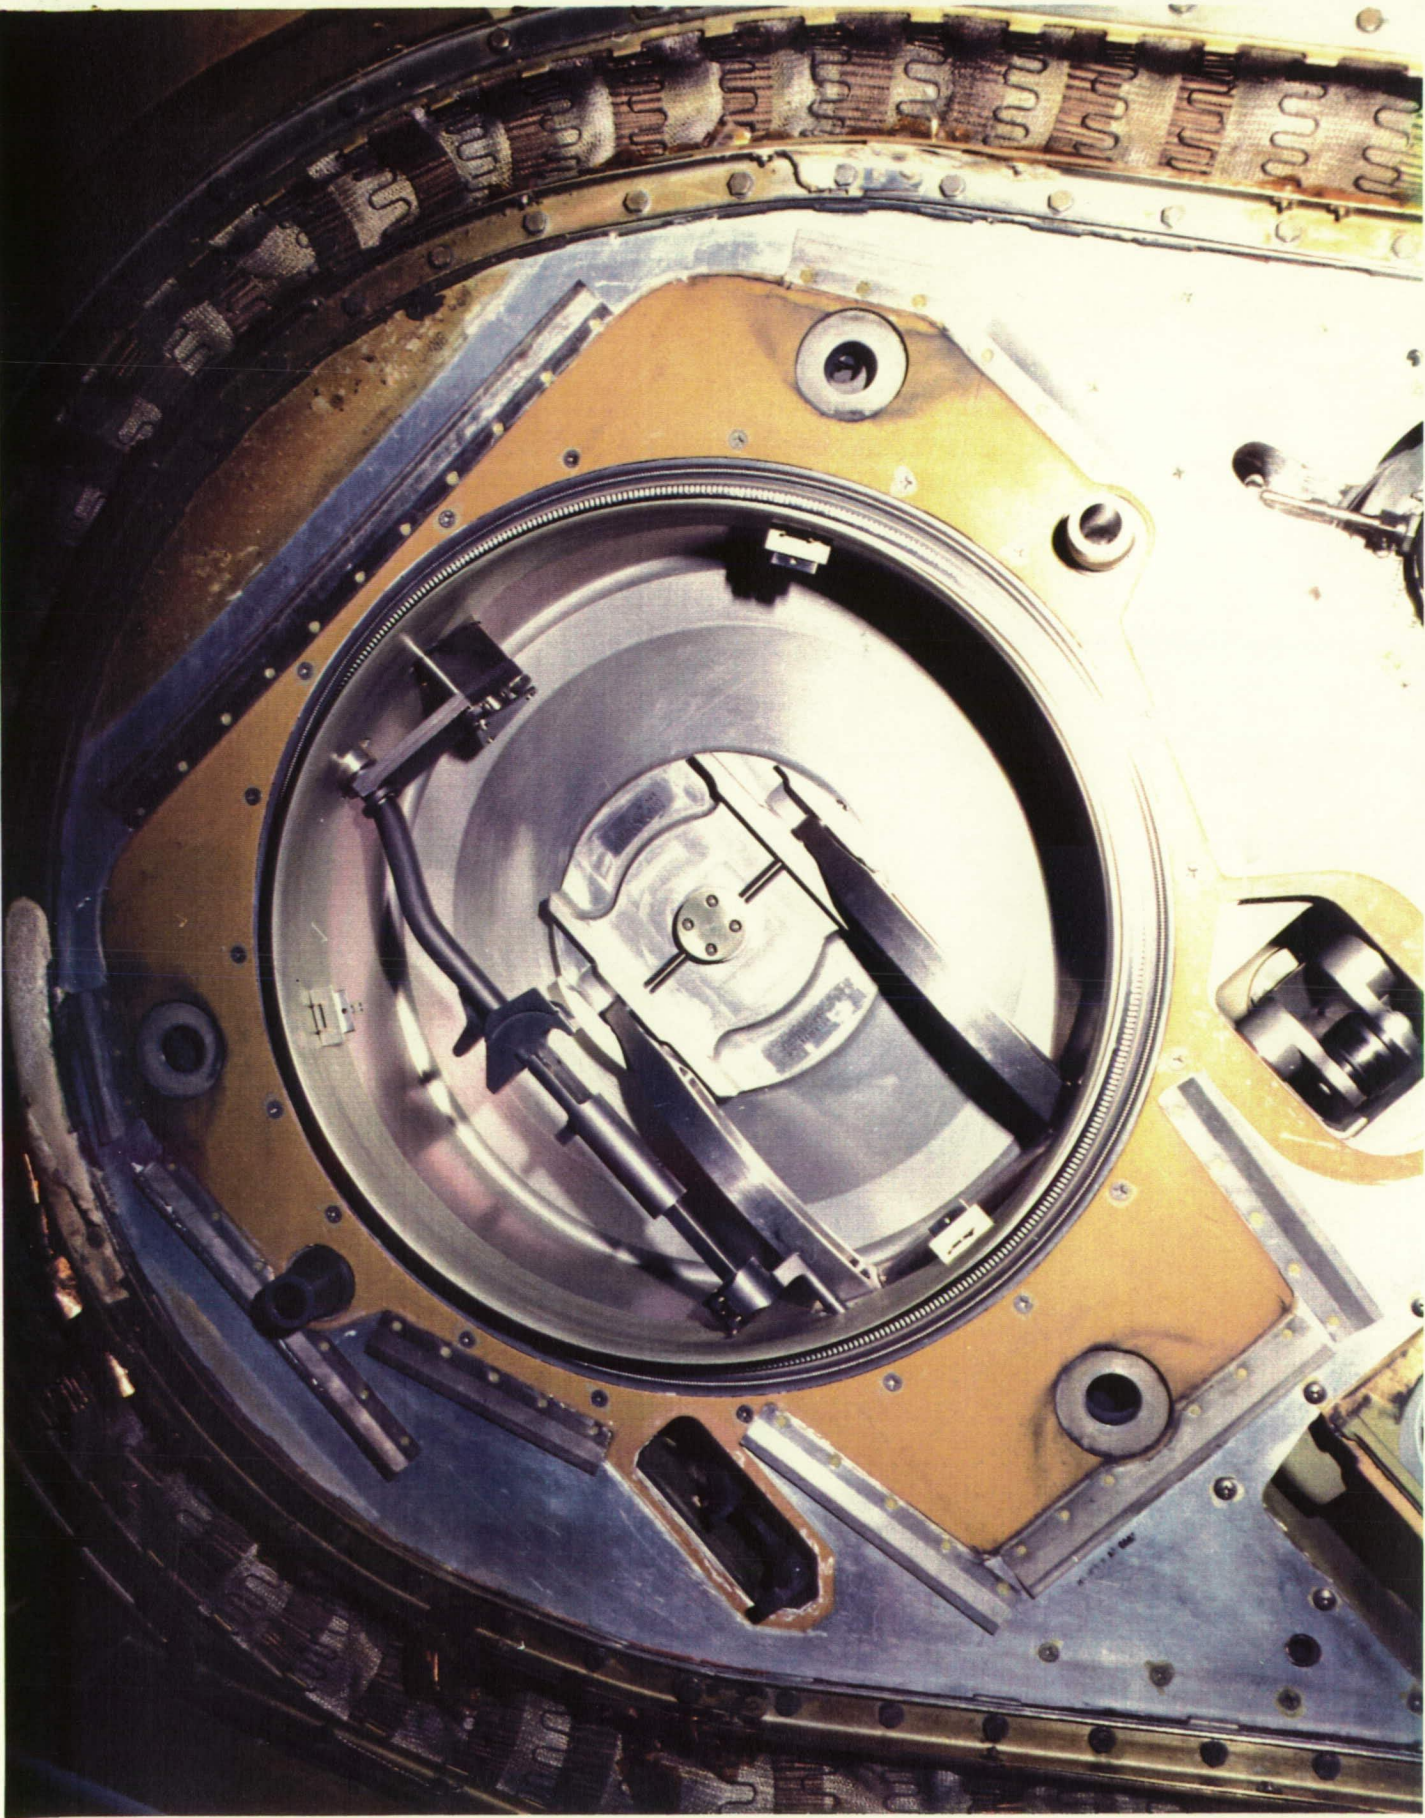
Overall view of the LH2 ET/ORB umbilical.
